Analysis of urban search and rescue markings applied following the 22 February 2011 Christchurch earthquake

Stephen Glassey MEmergMgt, NCUSAR, CEM®, MEPS

Institute of Risk, Resilience & Renewal, University of Canterbury

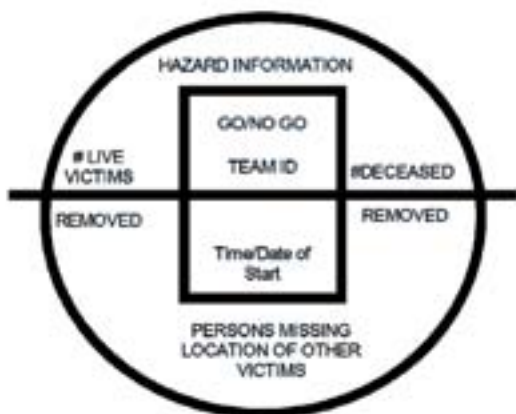
Figure 2: INSARAG Structural Marking

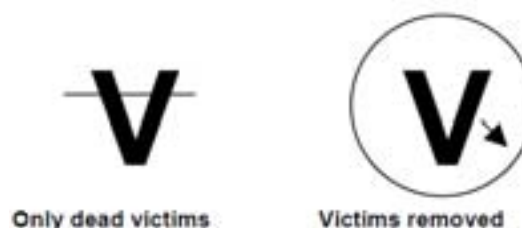
Figure 5: INSARAG Victim Marking (discontinued)

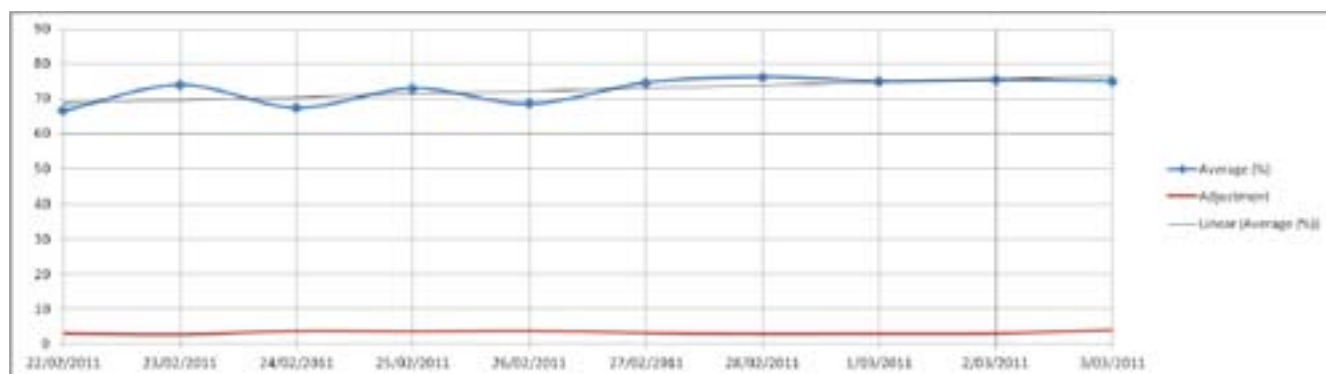
Figure 6: SMAS trends

There was an overall trend of improvement of search marking adherence as the incident progressed (figure 6). The Quantitative data in isolation does not provide any valid explanation for the minor increase in the scoring trend. Results from the survey shall be used to in conjunction with this data to make an informed analysis.

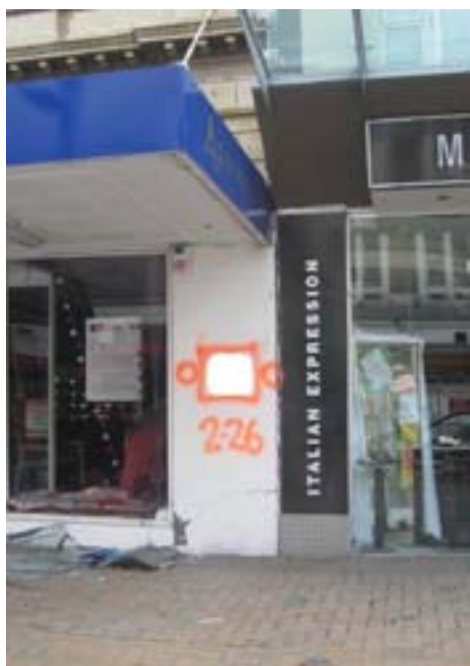
Figure 8 (International Team): Example of foreign date format. The size and location of the date is also non-compliant. Zero fields for victim information are also applied. Photo by Stuart Fraser.

Of the sample population (n=153), 66.01% of the markings were applied by International Teams, 24.84% by NZ Task Forces and the remaining 9.15% were applied by NZ Response Teams. No markings by other team types such as New Zealand Fire Service (Non-USAR), Red Cross or Land Search and Rescue were observed. Only 1 (0.65%) marking was identified to have followed the FEMA marking system, which was applied by a NZ Task Force. 24.84% (n=38) used the figure zero to indicate a null field (figure 8).

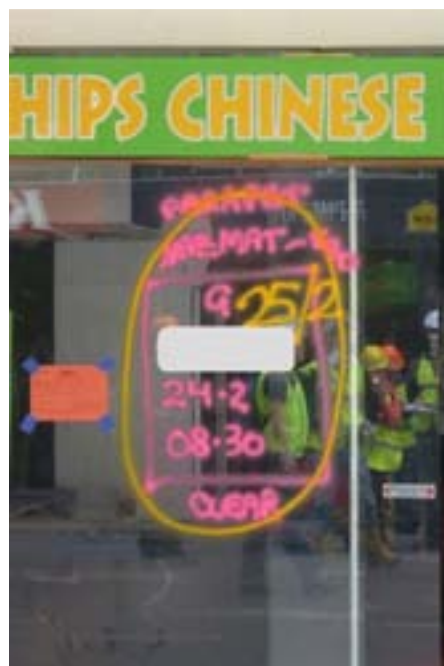
Figure 9 (NZ Task Force): Example of abbreviated Go/No Go, correct placement of hazard information, limited date/time, and incorrect indication of “clear” (line through marking not applied). Photo by Stuart Fraser.

Scoring of *Go/No Go* criteria showed a distinctive variance between NZ Response Teams (1.79) and International Teams (1.45) and NZ Task Forces (1.42), with an overall average of (1.55). The guideline requirements specified in F13.6 (United Nations, 2011, pp. 95-96) both in the text descriptor and example illustration clearly prescribe “Go” or “No Go”, however International and NZ Task Force team types were more prone to abbreviate these to “N” or “NG” (figure 9).

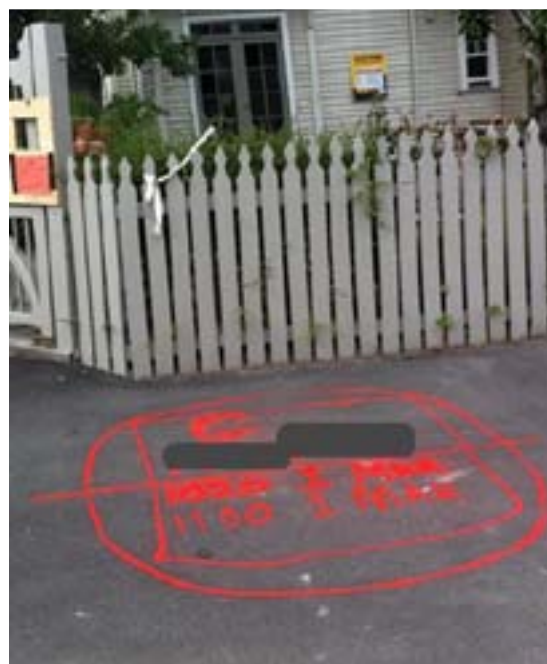
Figure 11 (NZ Response Team): Marking applied not on the structure, abbreviated “Go” and oversized. Note use of letters to denote month to avoid confusion with foreign date format. Horizontal line drawn through marking to mark as clear. Photo by Alan Keeber.

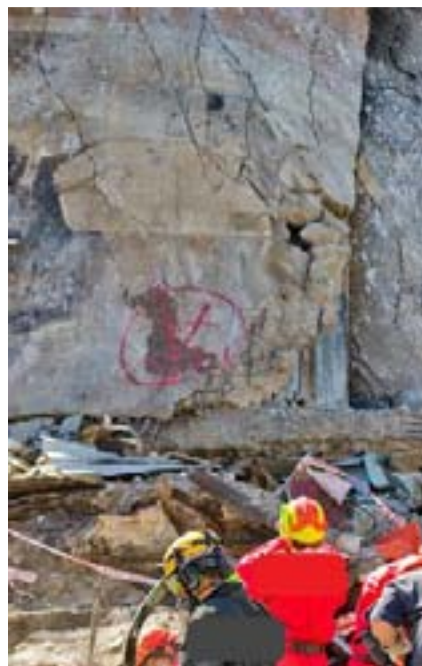
Figure 12. Victim marking. Photo by NZ Defence Force.

Victim Data adherence scored well with an overall average of 2.85 (NZ Response Teams 3.0, International Teams 2.89, NZ Task Forces 2.67). The use of the figure zero used (24.84%, n=38) to indicate a null field was mainly used by international teams and predominantly for victim data (figures 8 and 10). Despite the removal of victim markings (figure 4) from the guideline prior to 2006, there appeared to be a trend for some teams, both domestic and foreign to still apply these (Figures 12 and 13).

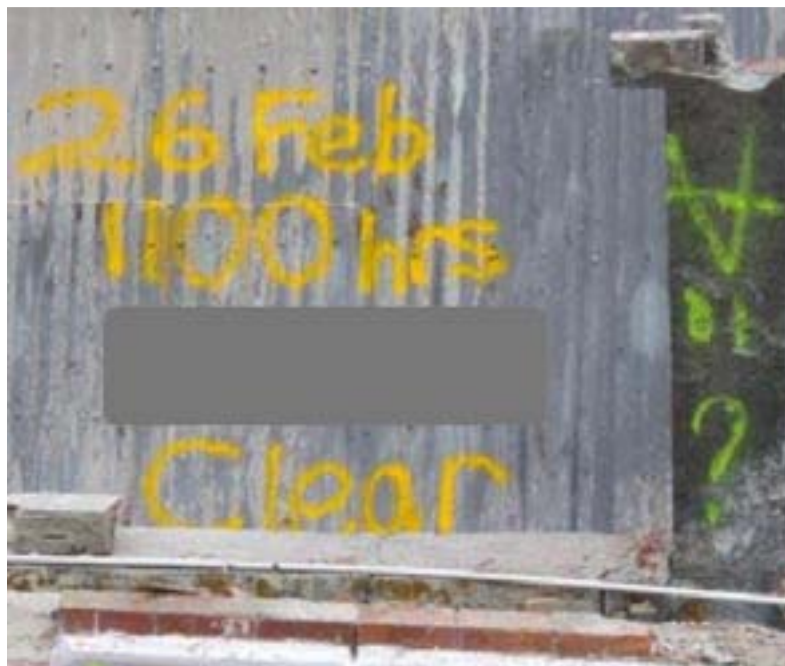
Figure 13: Victim marking. Photo by Phil Parker.
